ILLICIT DISCHARGE DETECTION & ELIMINATION PROGRAM 2023 Field Screening Program

Prepared for:
City of Marinette
December 15, 2023

RE: 2023 IDDE Program – 2023 Field Screening Program

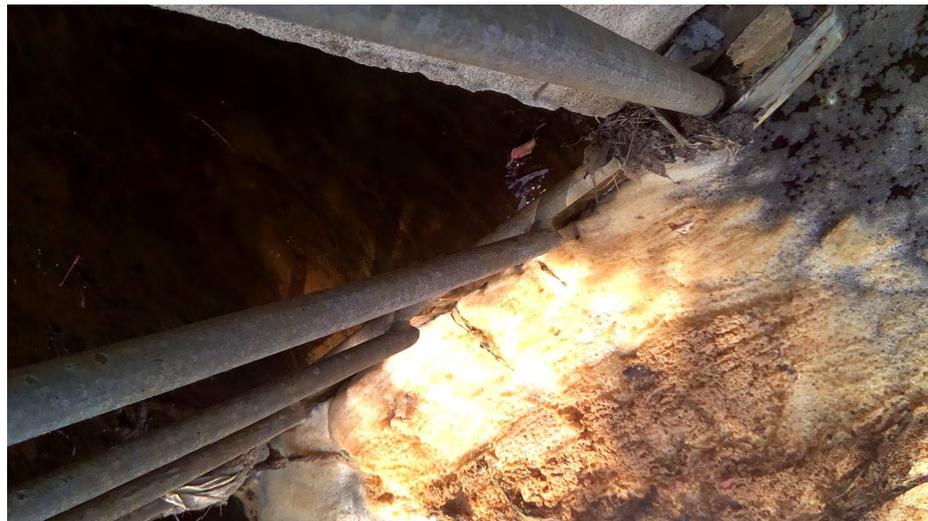
Potential for Illicit Discharge: Possible
Non-Illicit Discharge: None
 Other Comments: Outfall drains into river, high conductivity and slight Petroleum Odor

Pool from outfall, lots of foam. Photo rotated counter-clockwise.

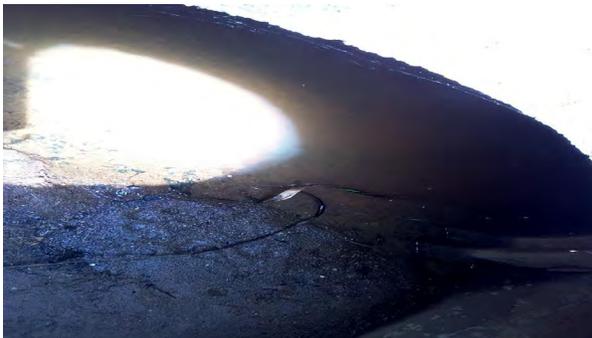
View from upslope manhole at the corner of Lake Street and Alameda Street. Photo Rotated.

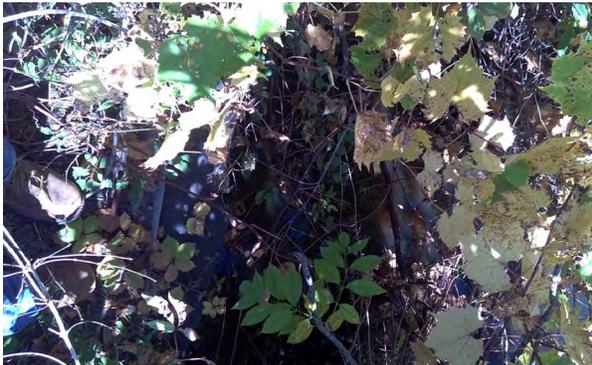
Potential for Illicit Discharge: Possible
Non-Illicit Discharge: Yes
Other Comments: Lots of overgrown vegetation, golden Yellow color of water potentially skewed some test results.

View from on top of culvert looking down. Photo Rotated.

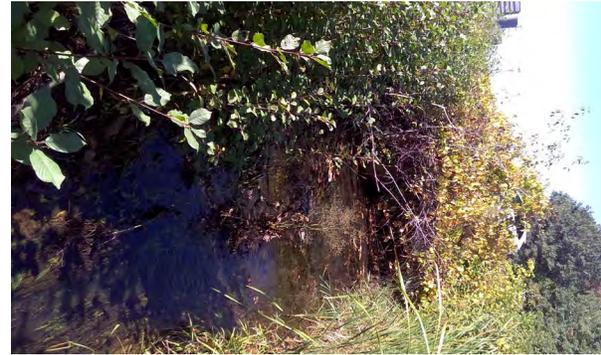
View of culvert facing towards Industrial Parkway South, water collected from here. Photo Rotated.

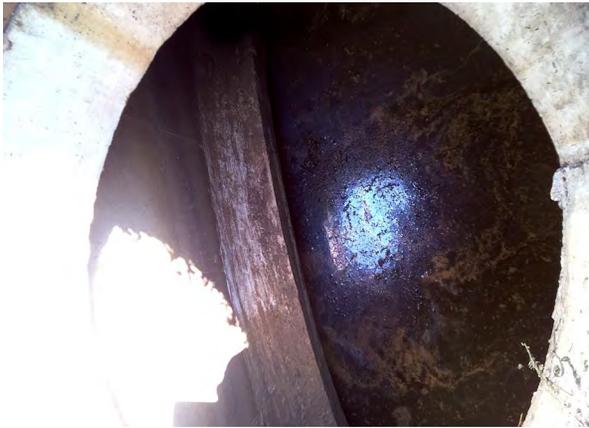
Other Comments: Upstream manhole at Stanton Street & Ludington Street. Strong Odor and high ammonia.

Outfall located between guard shack and railroad tracks. Photo rotated counter-clockwise.

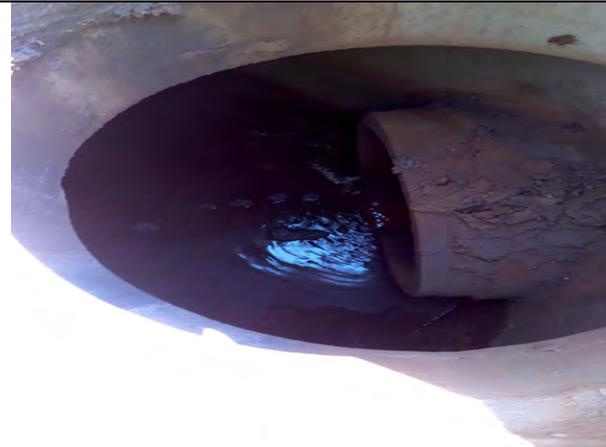
Upslope manhole at Ludington and Stanton with flow. Photo rotated counter-clockwise.

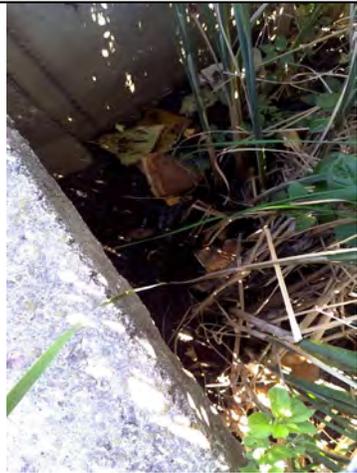
Dry ditch with few small puddles of stagnant water.

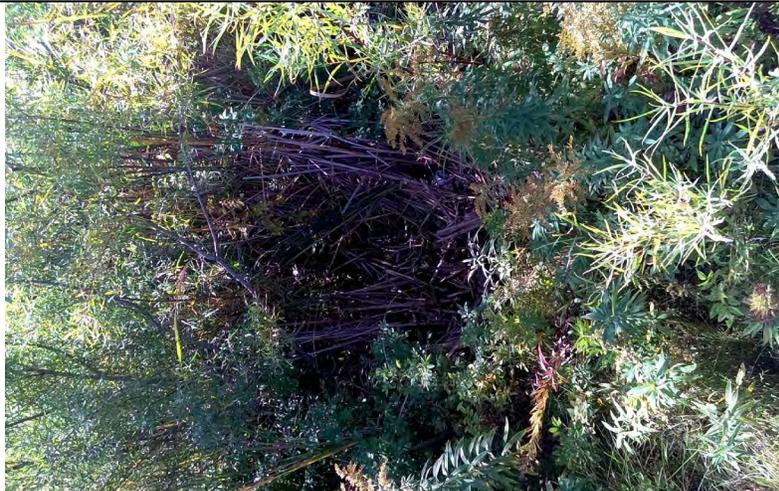
Other Comments: Overgrown vegetation surrounding culvert and along ditch.

View of culvert from above the culvert facing south, Cleveland Avenue behind. Photo rotated counter-clockwise.

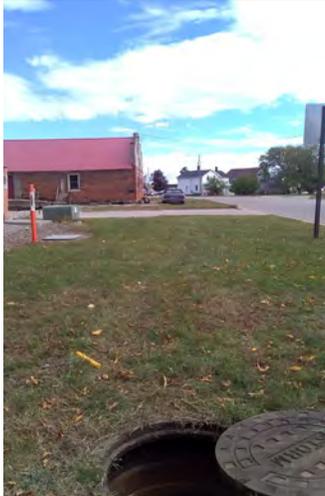
Fully submerged second upstream manhole, facing east towards first upstream manhole.

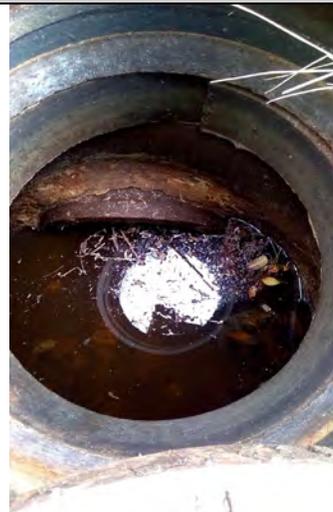
Partially submerged third upstream manhole slightly North of 2nd Street and Water Street.
